**BECADO PLACE
and
VISTA DEL MAR
THIRD YEAR (2011)
MONITORING REPORT**

Project No.:
927 CIF

Prepared for:
City of Fremont

Date Issued:
September 2011

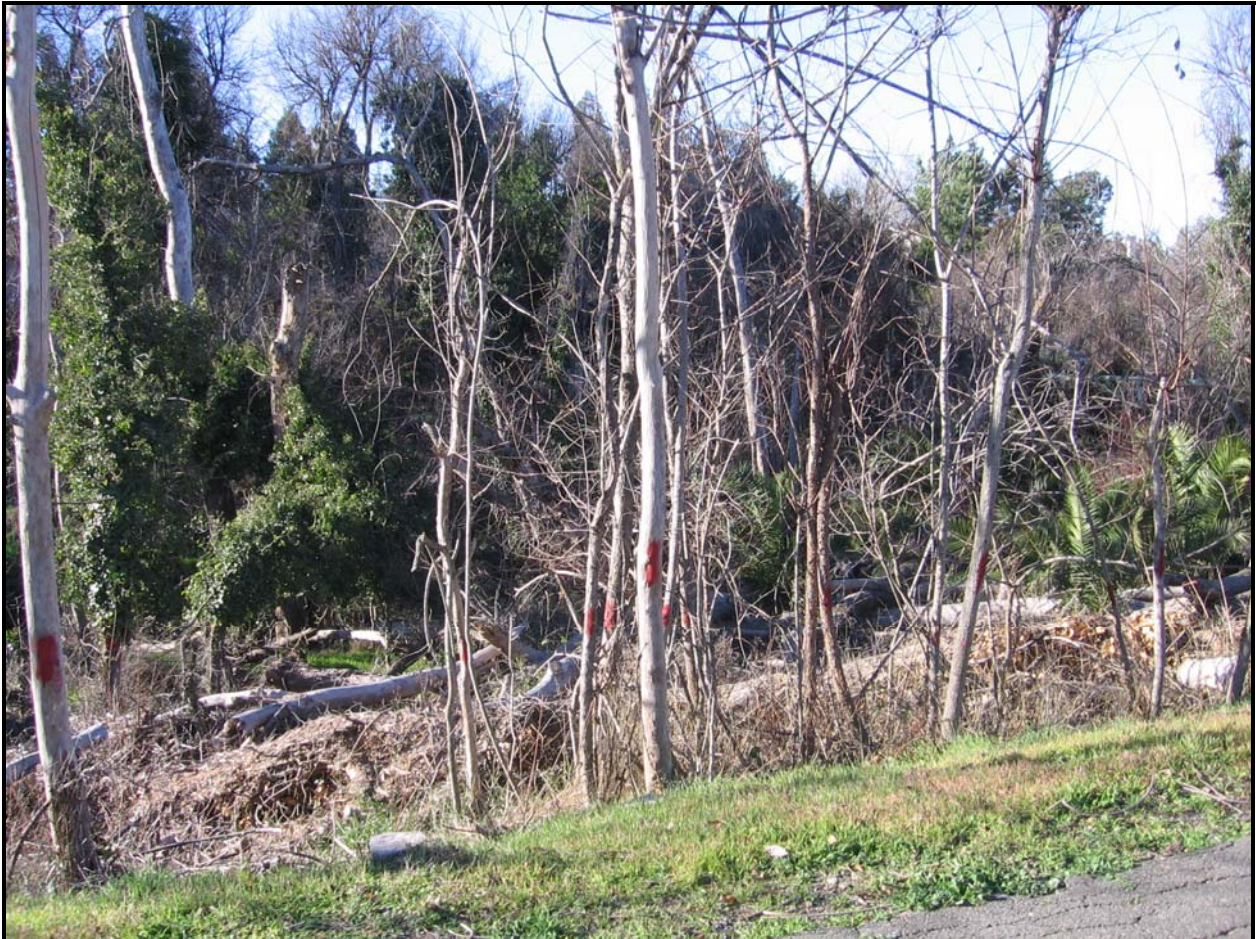
Photo 1: View of the site facing south towards Sabercat Creek from Becado Place before restoration work. The trees marked in red were removed prior to restoration. August 2008.

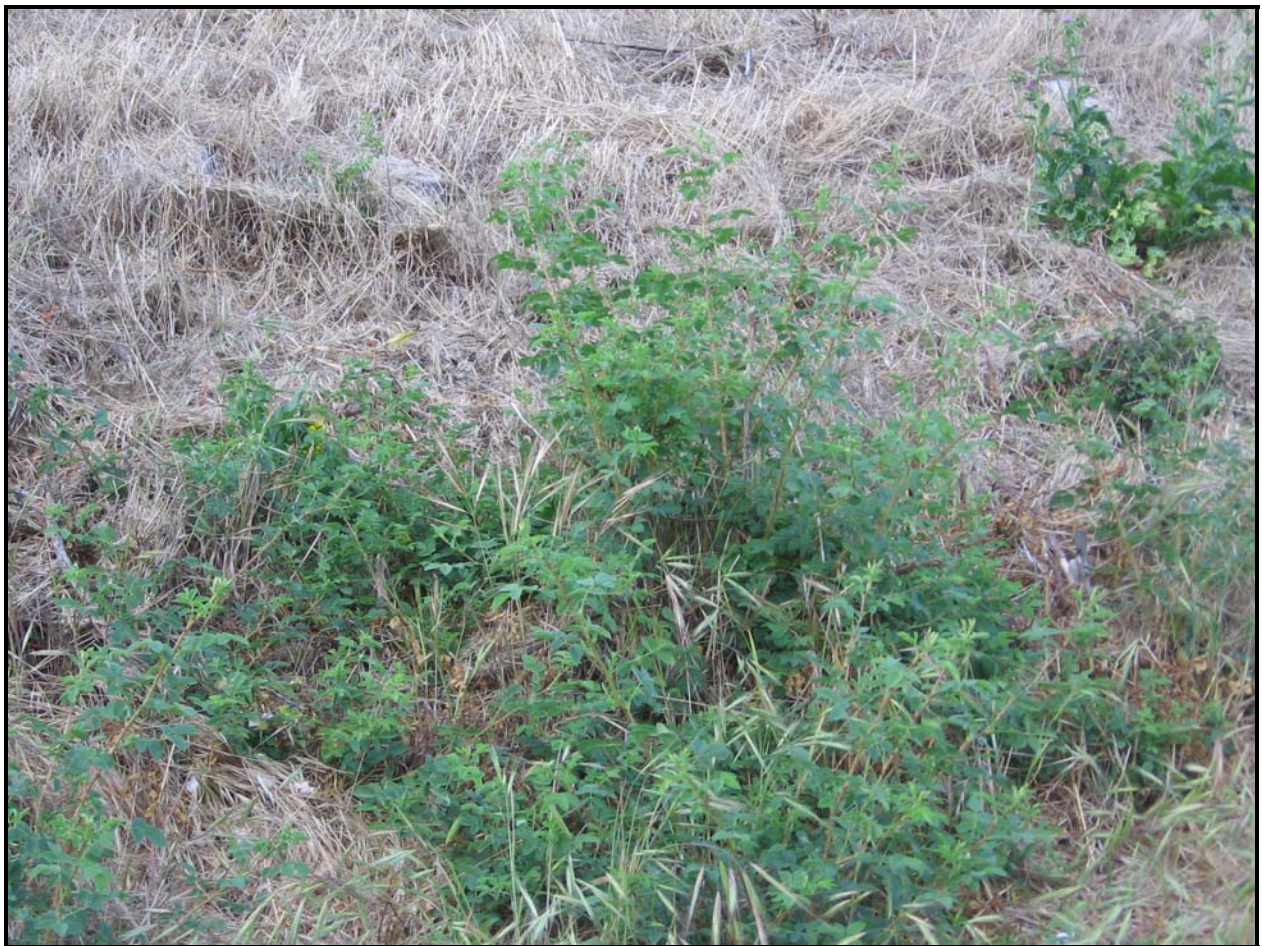
Photo 2: View of a typical wild rose (*Rosa californica*) shrub within the planting area that has begun to spread. June 2011

While the total survival remains moderate, the success of the wild rose is encouraging. These plants continue to thrive even with the high weed competition and no irrigation. If the site is not re-worked (see below), irrigation should be provided to the woodland vegetation, additional wild rose and creeping wildrye should be planted to boost overall numbers to their required levels and cover and keep down invasive weeds. Similar vegetation such as golden current (*Ribes aureum*), mugwort (*Artemisia douglasiana*), thimbleberry (*Rubus parviflorus*), and grey willow (*Salix exigua*) could also be attempted in order to boost the diversity of the woodland plantings.

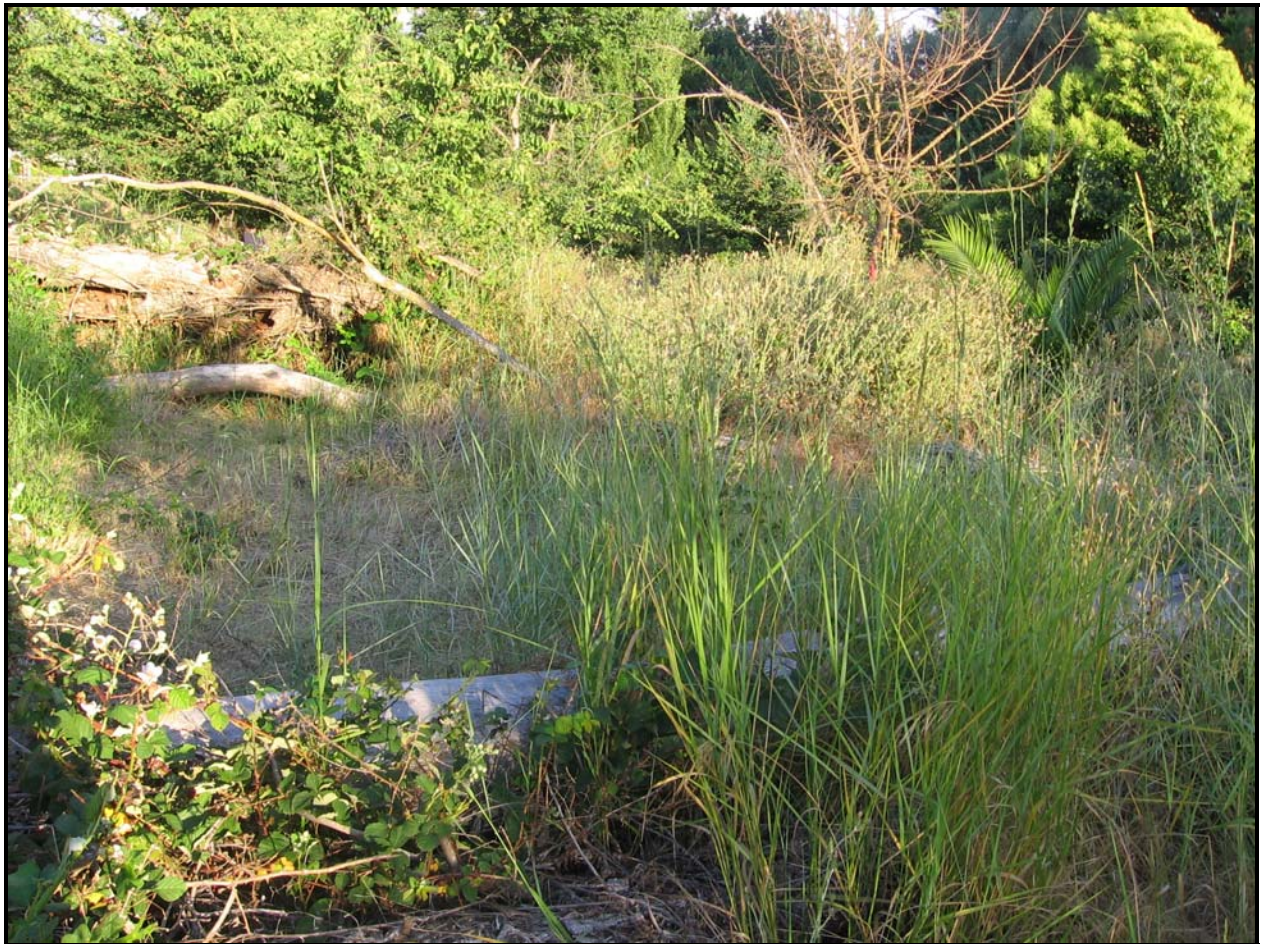
Photo 3: View of a patch of vigorous creeping wildrye (*Leymus triticoides*), a native grass that has spread within the planting area. Note the presence of weeds outside of the wildrye area. June 2011
